dsPIC33CH128MP508 Family Silicon Errata and Data Sheet Clarification

The dsPIC33CH128MP508 family devices that you have received conform functionally to the current Device Data Sheet (DS70005319D), except for the anomalies described in this document.

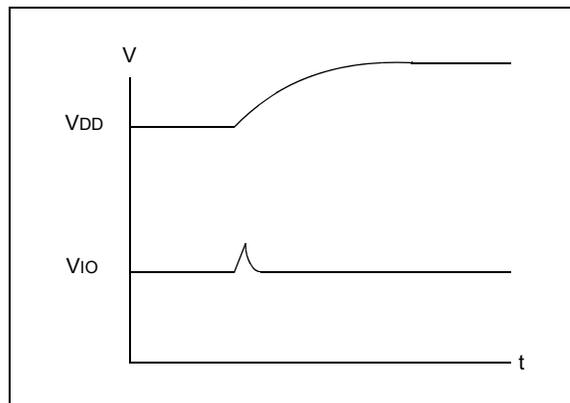
FIGURE 1: I/O RAMP

During a fast device power-up, when the V_{DD} ramp is less than 4 mS, the I/O pins may drive up to 100 μ A current for a duration of up to 10 μ S (Figure 1).

Example applications affected may include complementary power switches, where a transient current shoot-through might occur.

1. Slow down the V_{DD} ramp time (greater than 4 mS for V_{DD} to ramp 0V to 3.3V).
2. Ensure the circuitry that is connected to the pins can endure this pulse.

High-voltage applications with complementary switches should power the high-voltage 200 μ Sec later than powering the dsPIC[®] device to avoid the current shoot-through. This behavior is specific to each device and not affected by aging.

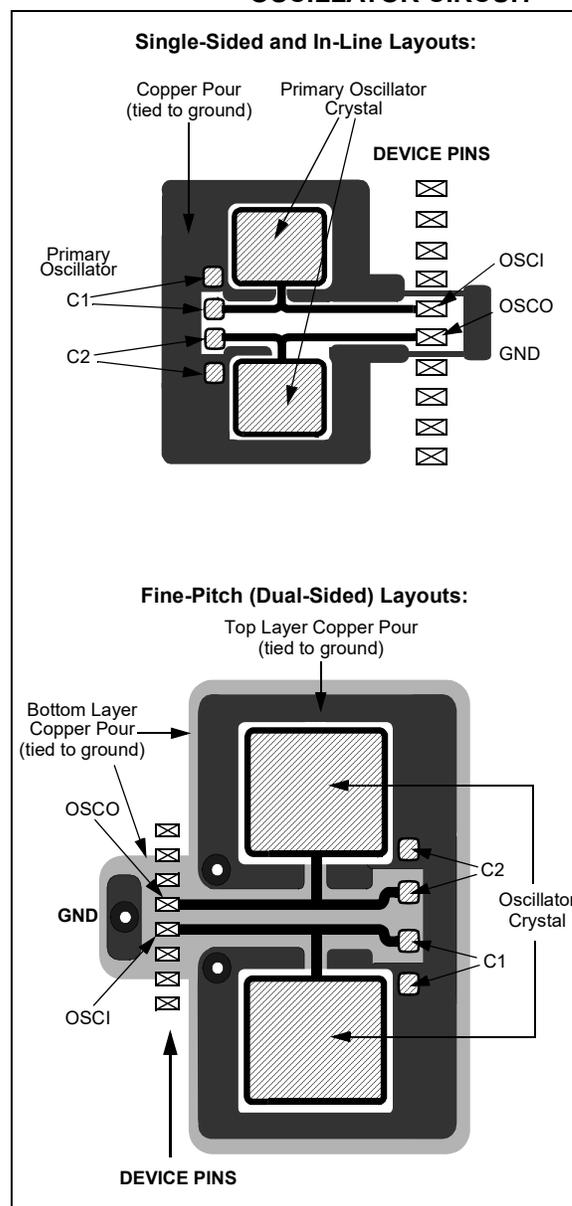
FIGURE 2-2: SUGGESTED PLACEMENT OF THE OSCILLATOR CIRCUIT

When the Primary Oscillator (POSC) circuit is used to connect a crystal oscillator, special care and consideration is needed to ensure proper operation. The POSC circuit should be tested across the environmental conditions that the end product is intended to be used. The load capacitors specified in the crystal oscillator data sheet can be used as a starting point, however, the parasitic capacitance from the PCB traces can affect the circuit and the values may need to be altered to ensure proper start-up and operation.

able solution is to tie the broken guard sections to a mirrored ground layer. In all cases, the guard trace(s) must be returned to ground.
